# Oyster Bed Mapping in the Great Bay Estuary, 2012-2013

A Final Report to  
The Piscataqua Region Estuaries Partnership and  
New Hampshire Department of Environmental Services

Submitted by  
Raymond Grizzle and Krystin Ward  
University of New Hampshire  
Jackson Estuarine Laboratory, 85 Adams Point Road  
Durham, NH 03824

June 26, 2013

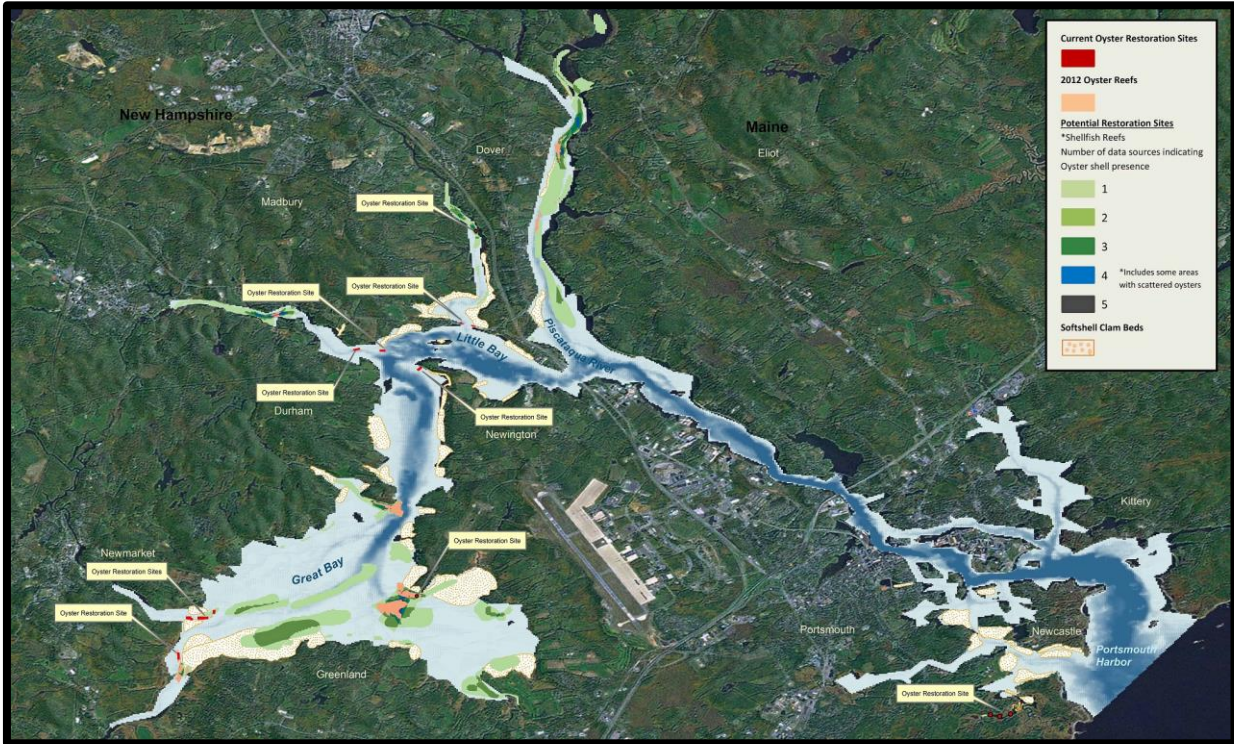
Fig. 2. Locations where live oysters (green to blue polygons) were shown on historical maps; note color coding to show the number of historical maps where each bed was shown, thus giving an estimate of accuracy), and major recent oyster restoration projects (revised from Odell et al. 2006) (also see Fig. 1).

is also a need to determine the boundaries of some of the oyster restoration projects that have been conducted since 2000. Therefore, the second objective of the present project was to map as many of the areas as practical where available information indicated live oysters historically occurred in the Great Bay Estuary, and where major recent restoration projects have been completed (Fig. 2).

The natural oyster reef shown on some historical maps (Fig. 2; also see Odell et al. 2006) in the channel area of middle and western Great Bay was found to be extensive, with “reef” (>20% shell and live oysters visible) area covering 35.2 acres (Fig. 11; Appendix B). The general area also included a substantial amount of sparse shell bottom, mostly consisting of dead oyster shell. The extent of live oyster reef in this area was surprising. Moreover, the extent of sparse shell bottom extending away from the main reef at both ends (east and west) likely indicated the historical spatial extent of this reef. This spatial arrangement of features—a central area of dense live oysters with adjacent areas of sparse mostly dead shell—suggests excellent conditions for future oyster restoration projects. Additionally, the same general situation exists in the nearby Nannie Island/Woodman Point reef area. Therefore, a map showing these conditions as well as the most recent available (from 2012) map of eelgrass was produced to illustrate the extent of potential oyster restoration sites for central Great Bay (Fig. 11). Although more detailed mapping of each of the six potential oyster restoration areas would be needed to adequately design each project, we estimate that >100 acres of bottom area likely represents excellent oyster restoration opportunities.

The general area of a historical natural oyster bed in southeastern Great Bay at the mouth of the Winnicut River (see Fig. 2 above) was surveyed by navigating a zig-zag pattern out of the River and probing the bottom with a PVC pipe to determine bottom type (Fig. 12). The entire area consisted of muddy substrate, very soft in many places. Shell material was only encountered in a few areas near mid-channel just south of Pierce Point, and included shell material beneath several centimeters of bottom sediment. No “hard bottom” was encountered.

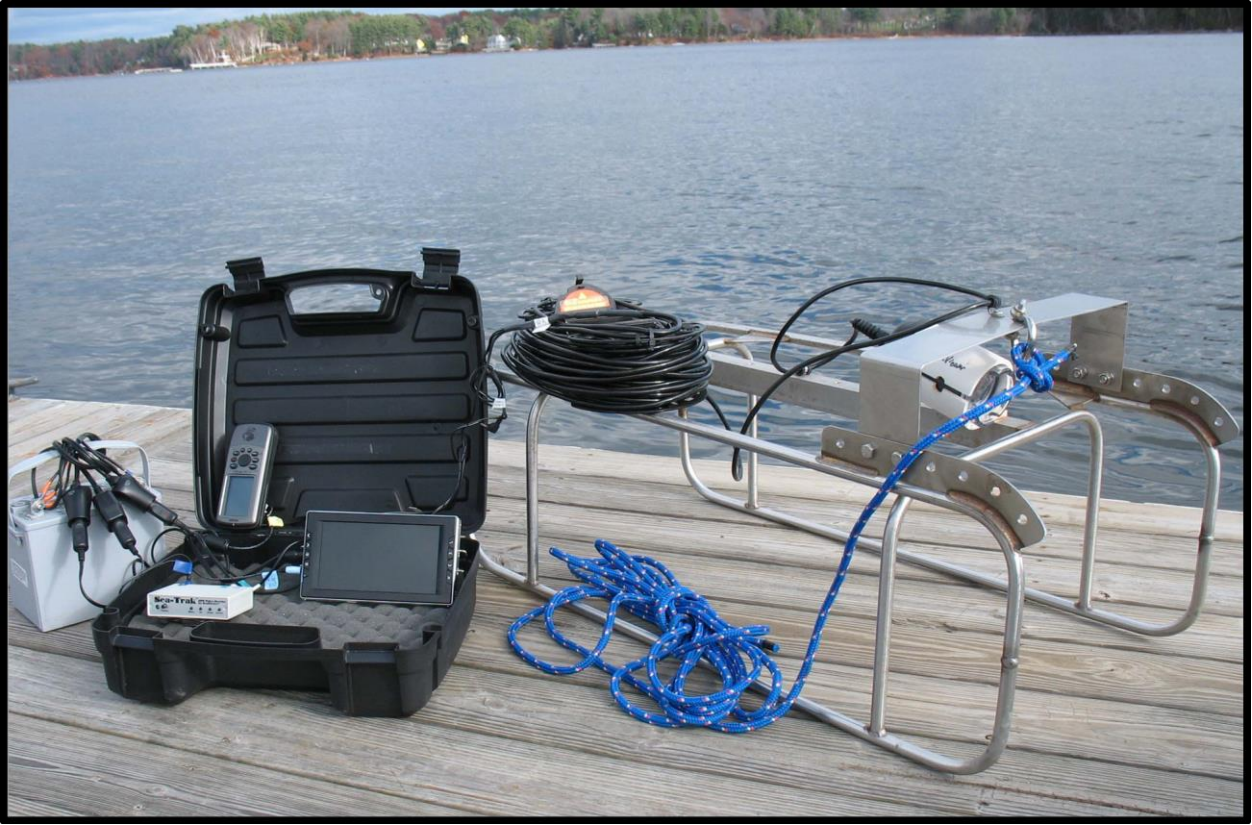
Fig. 3. Towed underwater video system showing major components (see text for details).

Towed underwater videography was used to map the six major oyster beds in the Great Bay Estuary system that are regularly sampled by NHF&G (Objective 1; see above), and historical beds and major restoration areas (Objective 2; Table 1). Methods used in previous surveys (Grizzle and Brodeur 2004; Grizzle and Ward 2009) and as described in detail in Grizzle et al. (2008) were used in the present project. Briefly, a video system consisting of a SeaViewer model 550 color camera was deployed in towed mode on a sled with imagery continuously recorded onto a digital video recorder along multiple transects across each mapping area and extending beyond the boundaries of where live oysters were observed (Fig. 3). A Garmin 76CSx GPS unit was used with WAAS mode activated and horizontal position data recorded near-continuously along each shiptrack and overlaid onto the video imagery. A minimum of five transects were traversed along the major axis of each mapping area with 5 to 20 m distance between transects. All imagery was reviewed in the laboratory and classified into one of two categories: “non-reef” (<20% shell cover, no live oysters visible) and “reef” (>20% shell cover and potentially [based on video imagery] live oysters).

At each site surveyed, a SeaViewer model 550 color video camera was deployed in towed mode on a sled with video imagery continuously recorded onto a digital video recorder. Garmin 76CSx and 541s GPS units were used with WAAS mode activated, with horizontal position data (advertised positional accuracy: 3 m) recorded near-continuously along each shiptrack. The imagery was viewed in real-time to locate areas with significant amounts of oyster shell and live oysters. When oysters were encountered, the extent of the oyster bottom in that area was delineated by navigating multiple parallel transects. All imagery was later reviewed in the laboratory and classified into the category of: "high density" oysters (>20% cover by shell and some live oysters visible). This provided near-continuous classification of the seafloor along each shiptrack. The Adams Point Oyster Bed polygon is 15.9 acres.

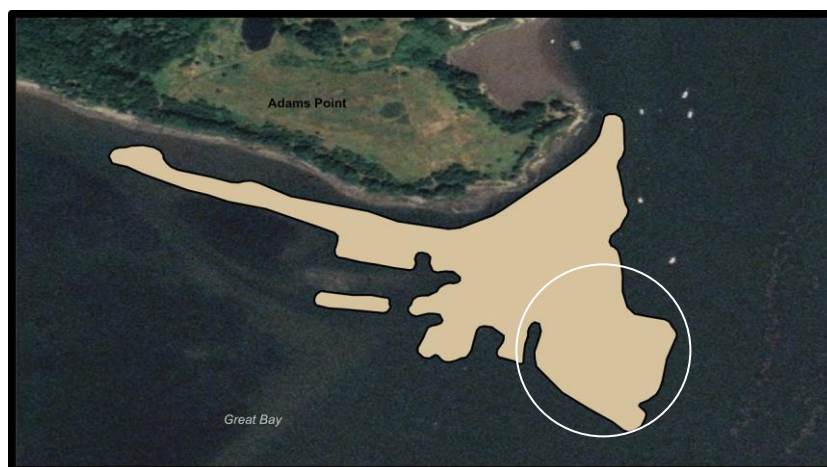
Fig. 4. Polygon for Adams Point reef based on video imagery recorded on October 8, 2012. Circle indicates bottom area probably not mapped in previous recent surveys (see Appendix A for metadata).

The Adams Point reef area appears to have increased substantially compared to the 2001 survey (Table 2). Most of the increase, however, is likely due to a new area being surveyed in 2012 southeast of the main portion of the reef (Fig. 4). Previous video surveys (e.g. Grizzle et al. 2008b) had not imaged this area due to water depth or other reasons. A portion of this “new” area had dense cover by live oysters, and had the overall appearance

of a healthy reef. Based mainly on the contiguous nature of the new area with previously mapped portions of the reef, it seems likely that this area had just been overlooked in previous surveys.

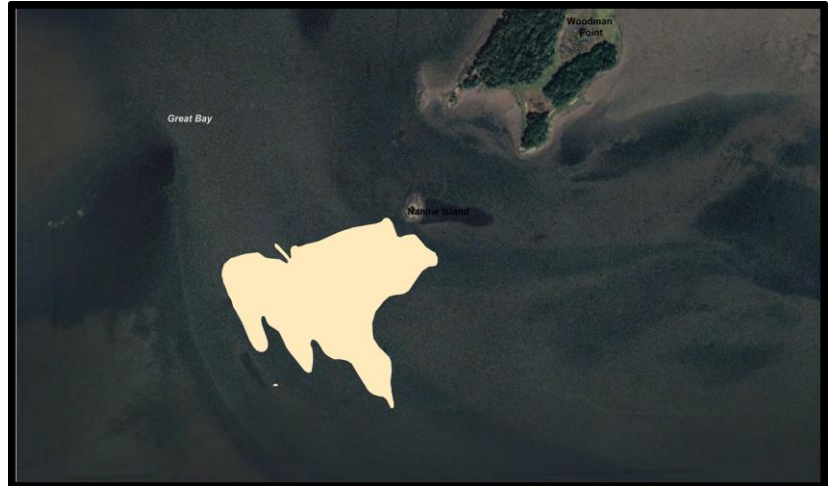
Fig. 5. Polygon for Nannie Island reef based on video imagery recorded on November 19, 2012 (see Appendix A for metadata).

The Nannie Island reef area mapped in 2012 was similar to that for 1997, but substantially less than that reported by NHF&G for 2001 (Table 2). As noted above, all previous mapping efforts differed in methods used and/or how “reef” or “shell bottom” area was defined. Thus, direct comparisons are not possible. Our previous studies on this reef using sonar methods and towed video (as in 2012) did not quantify bottom area coverage, but comparisons of the resulting polygons (see Figs. 13 and 15 in Grizzle et al. 2008b) indicate similar overall shape and size to that for 2012 (Fig. 5). Thus, although live oyster densities have varied substantially in recent years, we suggest that the total areal coverage by live oysters on the Nannie Island reef probably has not changed substantially in the recent past.

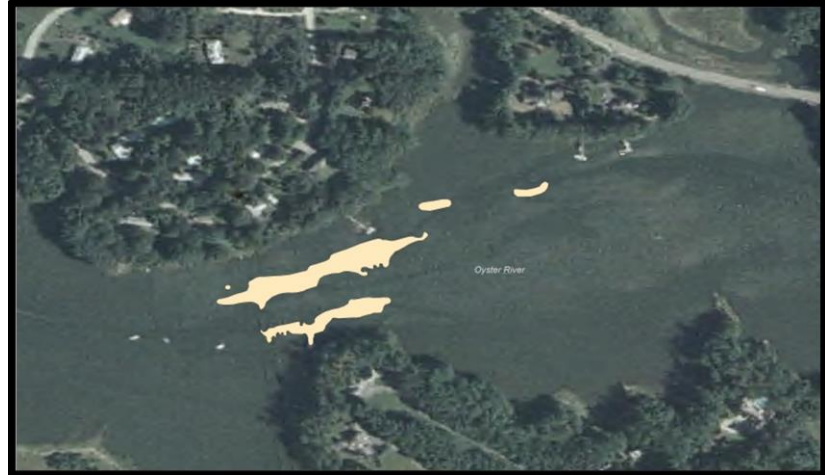
Fig. 6. Natural reef in Oyster River and two restoration areas based on video imagery recorded on November 15, 2012 (see Appendix A for metadata).

The reported Oyster River reef area coverage has only varied minimally since 1997 (Table 1). The shape of the reef, however, apparently has varied in the recent past. Previous video surveys had indicated live oyster bottom in the same overall area but no obvious “non-reef” area in the middle portion, as was found in the present survey (Fig. 6). Thus, it seems reasonable to conclude that the Oyster River reef may have decreased somewhat in size since the last survey in 2001. (See Objective 2 section below for discussion of restoration areas.)

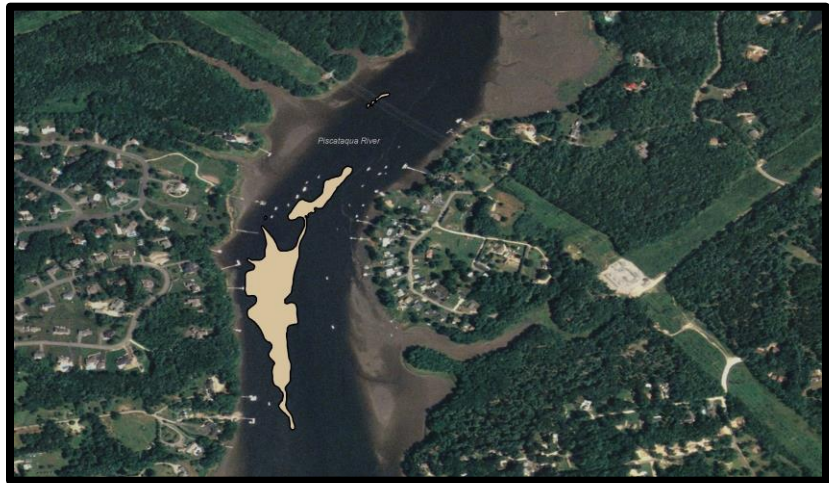
Fig. 7. Polygon for Piscataqua River reef based on video imagery recorded on November 6, 2012 (see Appendix A for metadata).

All previous surveys of the Piscataqua River reef reported much higher bottom area coverage compared to the present (2012) survey (Table 1). The general area mapped in the present survey was similar to that in previous surveys, and similar video methods were used (Grizzle and Brodeur 2004; Grizzle et al. 2008a). Also, the overall shape of the reef area was similar in 2012 in those areas where live oysters and >20% shell cover occurred (Fig. 7). Thus, it seems reasonable to conclude that the Piscataqua River reef has decreased substantially in areal coverage since the most recent previous survey was conducted (2003).

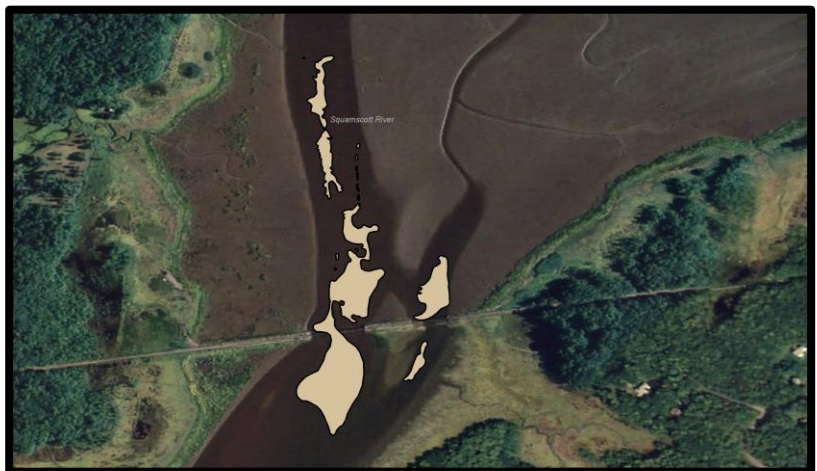
Fig. 8. Polygon for Squamscott River reef based on video imagery recorded on October 10, 2012 (see Appendix A for metadata).

The Squamscott River reef and the Woodman Point reef appear to have increased dramatically in size compared to previous surveys (Table 2). However, in both cases additional areas were imaged in 2012 compared to previous video surveys, thus making direct comparisons difficult.

The additional areas surveyed in the Squamscott River were mainly in an uncharted channel east of the main navigational channel where previous surveys had occurred (Fig. 8). When considering only those areas imaged in previous video mapping efforts, the overall shape and size of the polygons differ somewhat. For example, the area of the Squamscott reef south of the railroad trestle is larger than reported previously, but the northern area is smaller (compare Fig. 8 herein with Fig. 3 in Grizzle et al. 2008a).

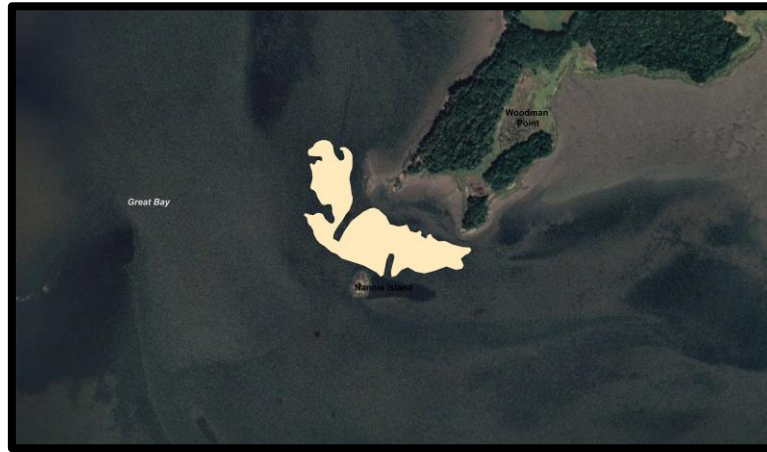
Fig. 9. Polygon for Woodman Point reef based on video imagery recorded on October 10, 2012 (see Appendix A for metadata).

In contrast, those areas of the Woodman Point reef video mapped previously are similar in shape and size to the 2012 survey. The additional areas surveyed for the Woodman Point reef were west of the extension of a rocky outcrop from the land north of the reef southward into the Great Bay (Fig. 9). Previous surveys (Grizzle et al. 2008b) had stopped at this point. During the present survey, the mapping was continued west of the outcrop and a substantial areal coverage of live reef was discovered. Areal coverage of this portion of the overall reef alone was approximately six

acres. If this “new” area is subtracted from the total areal coverage given in Table 2, then the 2012 data are similar to previous recent surveys.

Therefore, for both the Squamscott River and Woodman Point reefs we suggest that their bottom area coverage has probably remained relatively stable in recent years, and the additional reported coverage (Table 2) is a result of a more comprehensive survey in 2012 compared to previous efforts.

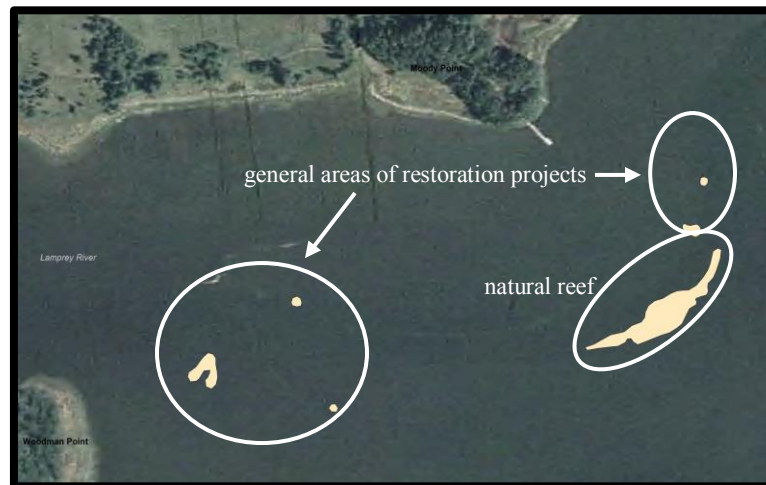
Fig. 10. Polygons for natural Lamprey River reef and two restoration areas based on video imagery recorded on June 19, 2013 (see Appendix B for metadata).

The Lamprey River survey area included a “new” natural reef that was thought to no longer exist, and two separate restoration areas (Fig. 10). Qualitative sampling on the natural reef indicated a substantial amount of vertical structure as well as some large (>100 mm shell height) individuals and multiple year classes on some clusters. The reef surface was also very hard and appeared to be quite thick, indicating many years of shell accretion. This is likely the historical reef known to have been in existence for decades. The restoration areas shown in Figure

10 were constructed in 2011 by deposition of a base layer of dead mollusc (mostly surf clams) followed by scattered live oyster spat-on-shell produced by remote setting. Most of the “reef” areas shown represent some combination of surf clam shell and live oysters from the spat-on-shell put out as part of the restoration process and naturally recruited oysters.

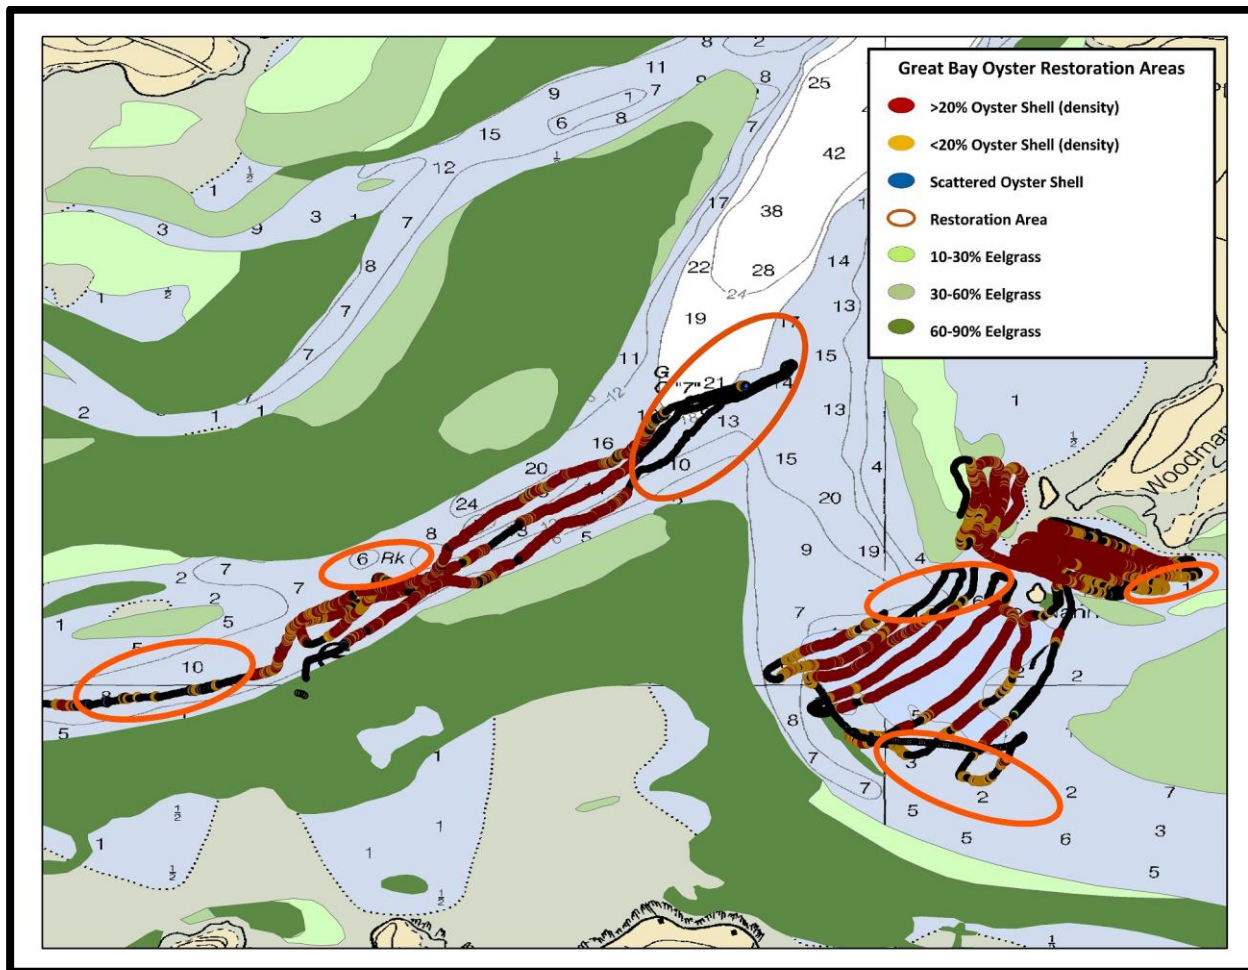
Fig. 11. Composite map showing potential oyster restoration areas (orange polygons) in Great Bay based on 2012 classified video shiptracks and recent (201x) mapping of eelgrass on bathymetric chart base map (water depth in feet).

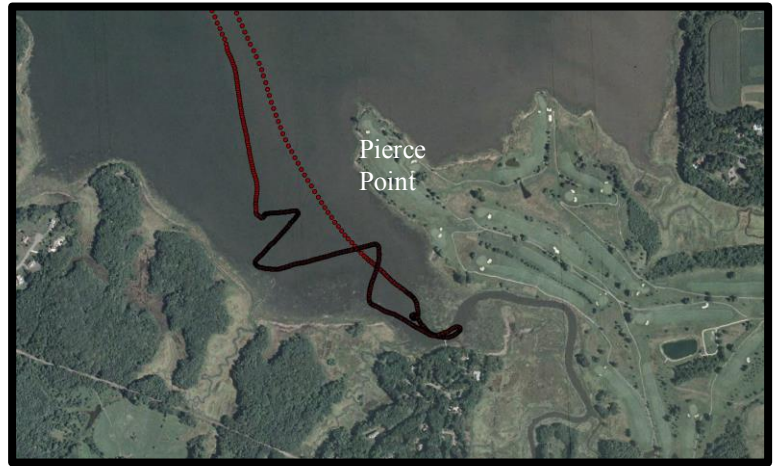
Fig. 12. Shiptracks recorded on June 19, 2013 showing area in southeastern Great Bay where oyster reef occurred historically.

This overall combination of conditions suggests that the reef may have been buried during a storm or other event involving substantial sediment transport. We have observed a similar situation in the Bellamy River at an oyster restoration site. Thus, we conclude that most likely this reef no longer exists.

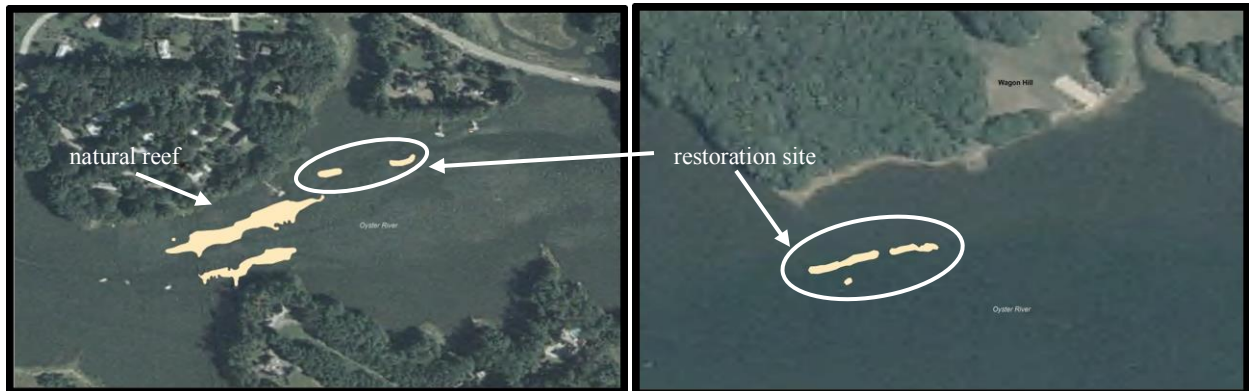
Fig. 13. Polygons showing extent of “shell bottom” at two oyster restoration sites in the Oyster River based on video imagery recorded on June 19, 2013 (See Appendix B for metadata).

In addition to the natural reef in the Oyster River, two oyster restoration sites were mapped in 2013. The first area was adjacent to the natural reef, and the second was near the mouth of the Oyster River (Fig. 13; also see Fig. 6 above). Both were constructed by deposition of a base layer of dead

mollusc (mostly surf clams) followed by scattered oyster spat-on-shell produced by remote setting. The video imagery indicated some combination of surf clam shell and live oysters in both areas. The video imagery confirmed the presence of abundant mollusc shell base material as well as live oysters in both areas. The base shell in most areas had a thin coating of silt, and some appears to have been substantially buried. Macroalgae had colonized the shell in many areas, and crabs and other invertebrates were visible in the imagery. These areas are scheduled for quantitative sampling and additional characterization by video and other methods in 2013.

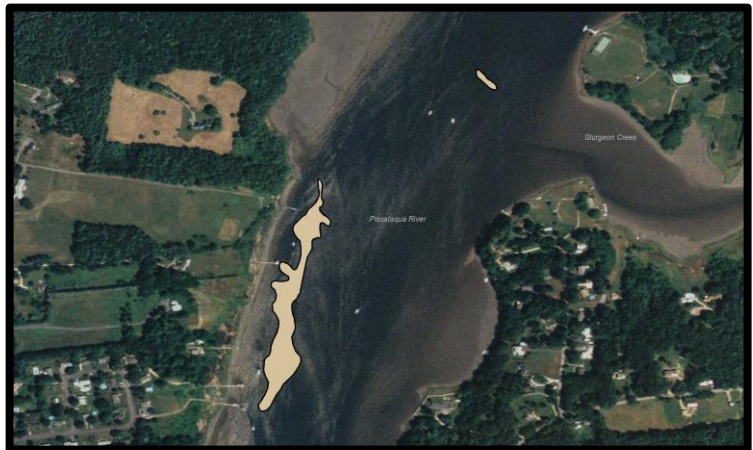
Fig. 15. Polygon for natural Piscataqua (South) River reef based on video imagery recorded on November 6, 2012 (see Appendix B for metadata).

In addition to the target survey areas listed in Table 1, a “new” natural reef was discovered in 2012 while using towed video to survey a potential restoration site in the Piscataqua River. This reef is south of the known Piscataqua River reef regularly sampled by NHF&G, but it is within the overall area of the upper Piscataqua River that historically had natural beds (Fig. 2). This “new” reef covered a bottom area of 3.9 acres, and represents a significant addition to the known natural oyster beds in New Hampshire (Fig. 15). A 1.5-acre area adjacent to and east of the natural bed is scheduled for construction/restoration in summer 2013. The restoration area will represent an addition onto the natural reef, likely in an area that historically was live oyster reef. The restoration area is scheduled for quantitative sampling and video mapping in 2013 and 2014.

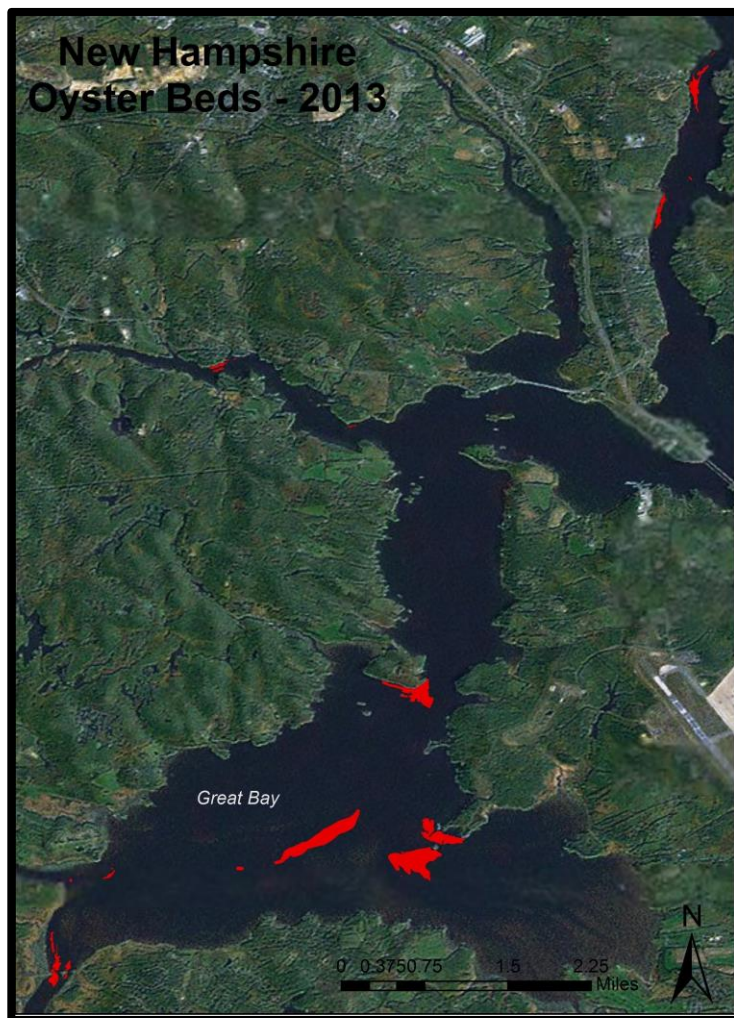
Fig. 16. Natural and restored oyster reefs mapped in the present project (red polygons).

The present study substantially expands the total bottom area coverage and overall distribution of known “oyster bottom” in New Hampshire. Figure 16 is an overview map showing both natural and restored oyster beds—defined as >20% shell cover and some live oysters observed in the video imagery—mapped in the present study. In sum, these areas total 120 acres. The major additions compared to previous surveys were two “new” beds, one in mid-Great Bay (35.2 ac) and one at the mouth of the Lamprey River (0.9 ac), that were known to occur historically but had not been surveyed in recent decades.

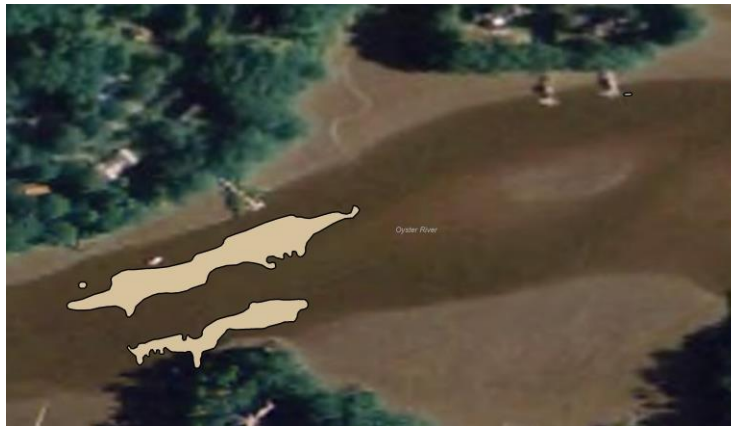
## Oyster River Oyster Bed

At each site surveyed, a SeaViewer model 550 color video camera was deployed in towed mode on a sled with video imagery continuously recorded onto a digital video recorder. Garmin 76CSx and 541s GPS units were used with WAAS mode activated, with horizontal position data (advertised positional accuracy: 3 m) recorded near-continuously along each shiptrack. The imagery was viewed in real-time to locate areas with significant amounts of oyster shell and live oysters. When oysters were encountered, the extent of the oyster bottom in that area was delineated by navigating multiple parallel transects. All imagery was later reviewed in the laboratory and classified into the category of: "high density" oysters (>20% cover by shell and some live oysters visible). This provided near-continuous classification of the seafloor along each shiptrack. The Oyster River Oyster Bed polygon is approximately 1.4 acres.

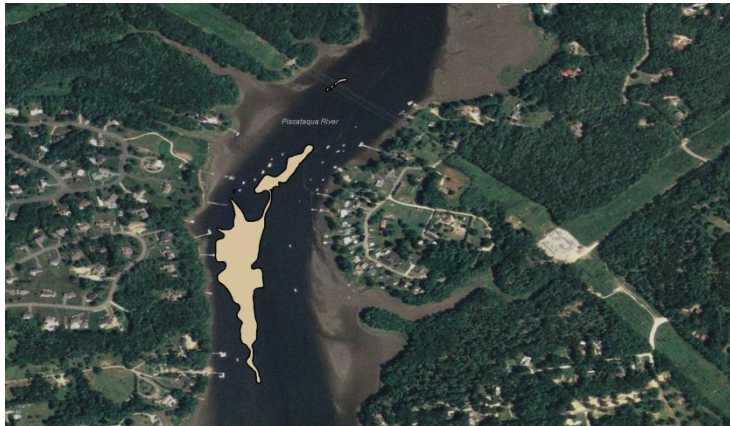
## Piscataqua River Oyster Bed

At each site surveyed, a SeaViewer model 550 color video camera was deployed in towed mode on a sled with video imagery continuously recorded onto a digital video recorder. Garmin 76CSx and 541s GPS units were used with WAAS mode activated, with horizontal position data (advertised positional accuracy: 3 m) recorded near-continuously along each shiptrack. The imagery was viewed in real-time to locate areas with significant amounts of oyster shell and live oysters. When oysters were encountered, the extent of the oyster bottom in that area was delineated by navigating multiple parallel transects. All imagery was later reviewed in the laboratory and classified into the category of: "high density" oysters (>20% cover by shell and some live oysters visible). This provided near-continuous classification of the seafloor along each shiptrack. The Piscataqua River Oyster Bed polygon is 7.7 acres.
